Manhole Inspection Summary

Manhole # S11QQ1015MH

Insp Date: **4/30/07 9:27 AM**

Location Address: **2726 CLYBURN AVE**

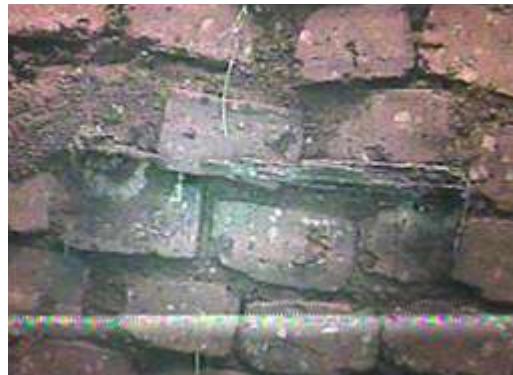
Defect 1

Steps Count: **2** Missing: **0** ☒ **Corroded**

CORRODED RUNG

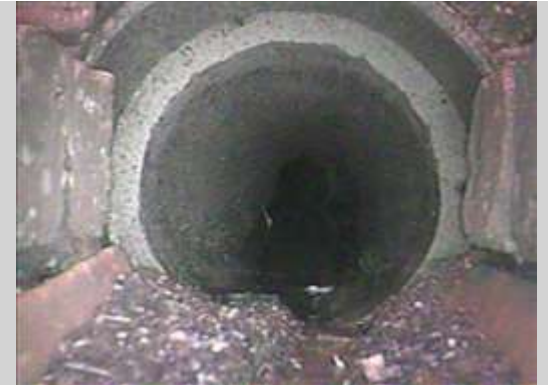
12 O'Clock Outflow

8 in. Circular Gravity Sewer
Pipe Out @ 12 O'Clock

Pipe Height: (in.) Direct
Pipe Material: **Clay** ☐ Pipe Lined
Invert Depth: **7.49** (ft.) Flow Characteristics: **Slow**
Deposits: ☒ None ☐ Mud ☐ Sludge ☐ Debris ☐ Grease
Silt Depth: (in.) Deposits Extent:
Infiltration: **None** Pipe Seal Cond: **Sound**

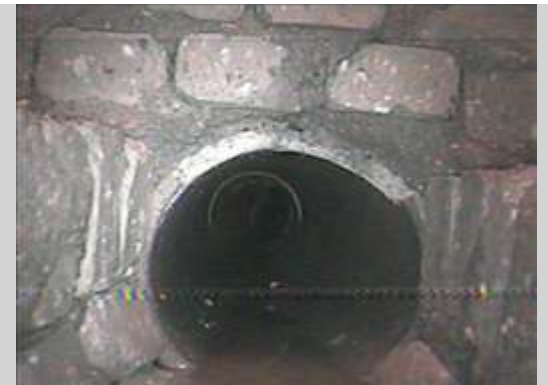
6 O'Clock Inflow

8 in. Circular Gravity Sewer
Pipe In @ 6 O'Clock

Pipe Height: (in.) Direct
Pipe Material: **Clay** ☐ Pipe Lined
Invert Depth: **7.45** (ft.) Flow Characteristics: **Slow**
Deposits: ☒ None ☐ Mud ☐ Sludge ☐ Debris ☐ Grease
Silt Depth: (in.) Deposits Extent:
Infiltration: **None** Pipe Seal Cond: **Sound**

Connects To: **Stub connection / abandoned**
